**DEPARTMENT OF TRANSPORTATION**

Contract #: 04-0120F4Cty: SF/ALA Rte: 80 PM: 13.2/13.9File #: 99.28**WELDING INSPECTION REPORT****Resident Engineer:**Siegenthaler, Peter**Address:** 333 Burma Road**City:** Oakland, CA 94607**Report No:** WIR-020546**Date Inspected:** 10-Feb-2011**Project Name:** SAS Superstructure**OSM Arrival Time:** 700**Prime Contractor:** American Bridge/Fluor Enterprises, a JV**OSM Departure Time:** 1900**Contractor:** Zhenhua Port Machinery Company, Ltd (ZPMC)**Location:** Shanghai, China

## WELDING INSPECTION REPORT

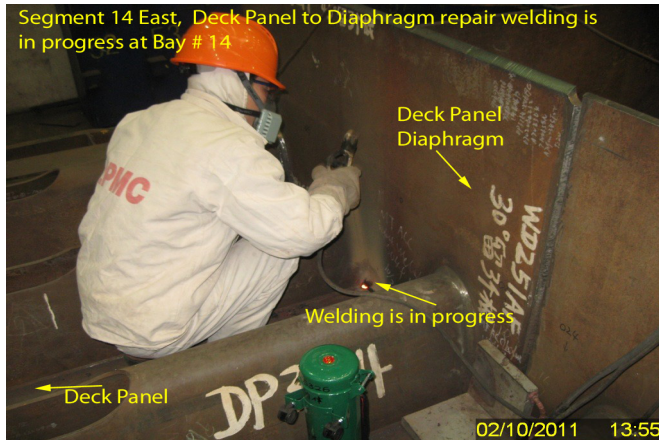
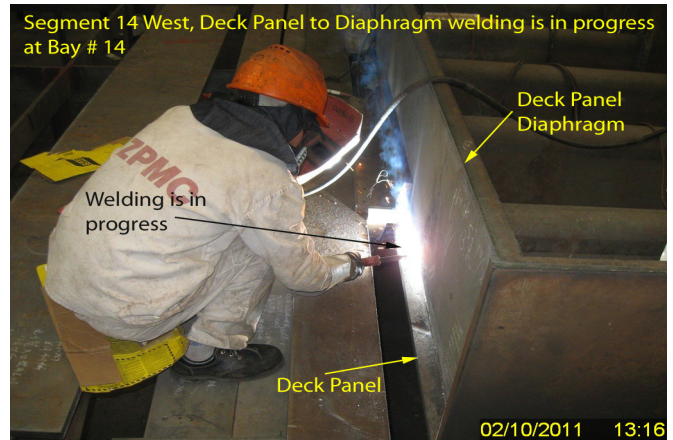
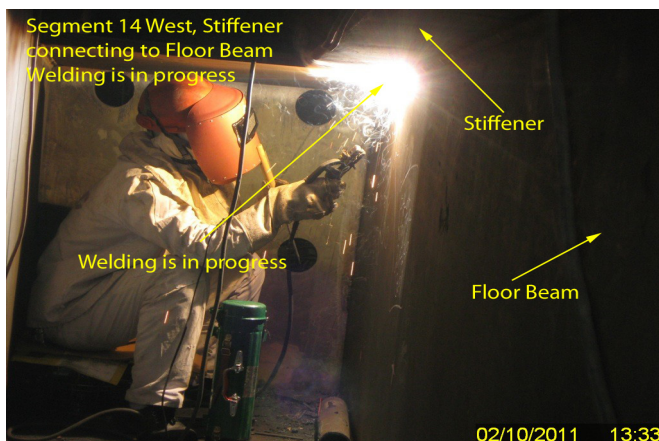
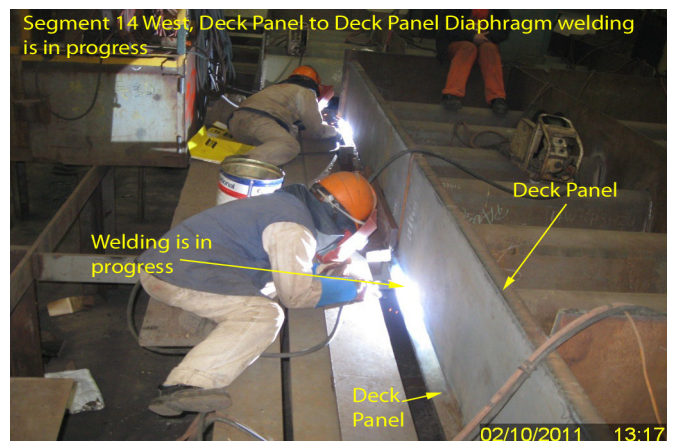
Unless otherwise noted, all work observed on this date appeared to generally comply with applicable contract documents.
